Briefing on Bay Bridge Bolts – July 10, 2013

THE SAN FRANCISCO-OAKLAND
BAY BRIDGE
SEISMIC SAFETY PROJECT

2008 Rods Failed Due to Hydrogen Embrittlement

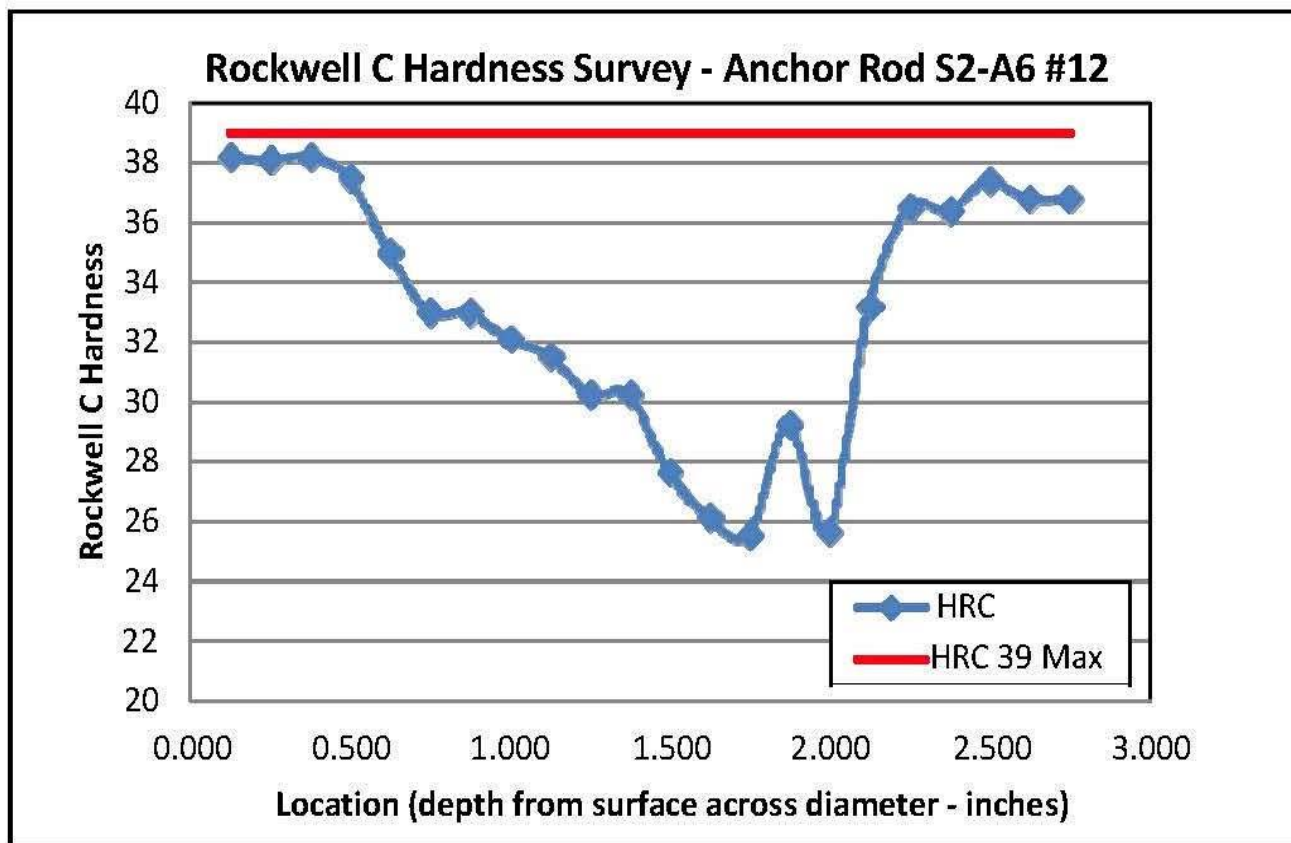
- Rods exhibited a material susceptibility to hydrogen embrittlement with a heterogenous structure and high surface hardness.

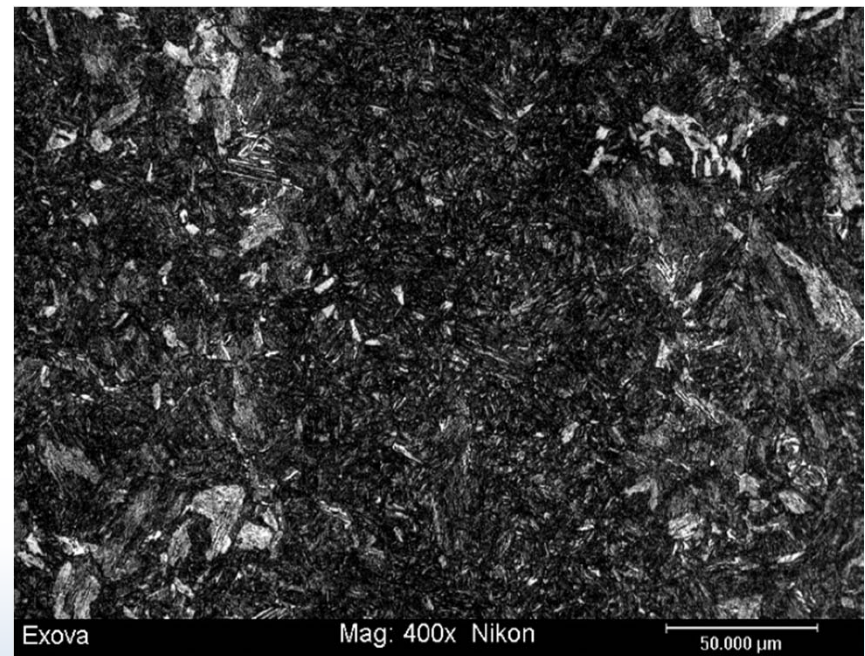
Other Rod

Essentially martensitic structure.

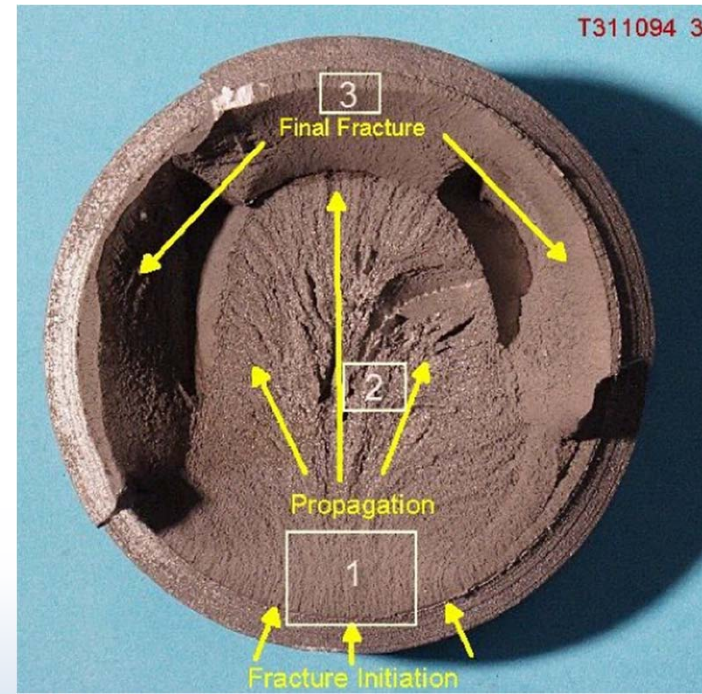
Other Rod

Ductile Failure in Lab Test
