**METROPOLITAN
TRANSPORTATION
COMMISSION**

RE: Transbay Transit Center Peer Review

Images

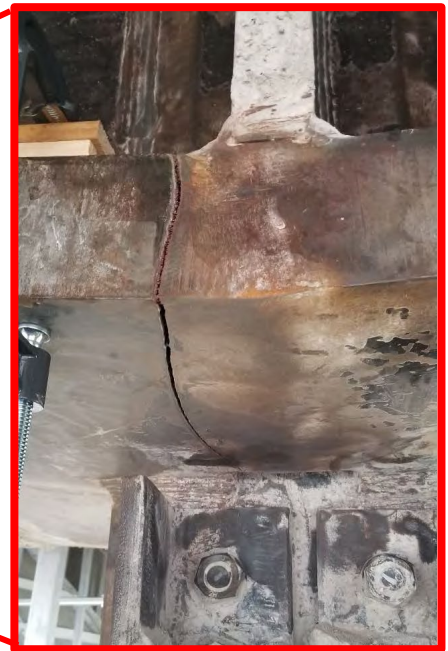
2. Hanger-to-girder connection at site of fracture (before fracture)

- August 12, 2018: Transit Center opens for bus operations.
- September 25, 2018: Workers installing ceiling panels discover a fracture in the bottom flange of a girder over Fremont (see Images 1-3 on page 3). TJPA closes the Transit Center. In the following days, TJPA discovers a fracture in a second similarly designed girder over Fremont Street. Two other girders over First Street share the design of the fractured girders but remain intact. TJPA installs shoring at Fremont and First Street.

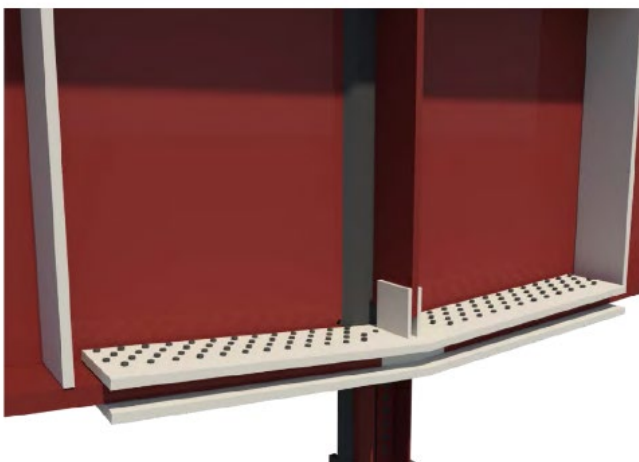
3. Fracture through bottom flange

In December 2018, the results of the material testing pointed to a preliminary hypothesis that the cause of failure was a result of: material properties (low fracture toughness at the mid-thickness of four-inch-thick steel plates); the presence of initiating defects (micro-cracks introduced by the flame cutting of slots); and stress across the fracture plane (residual stress due to adjacent welding, and applied stress from loads on the girders after erection).
