Briefing on Bay Bridge Bolts – July 10, 2013

THE SAN FRANCISCO-OAKLAND
BAY BRIDGE
SEISMIC SAFETY PROJECT

2008 Rods Failed Due to Hydrogen Embrittlement

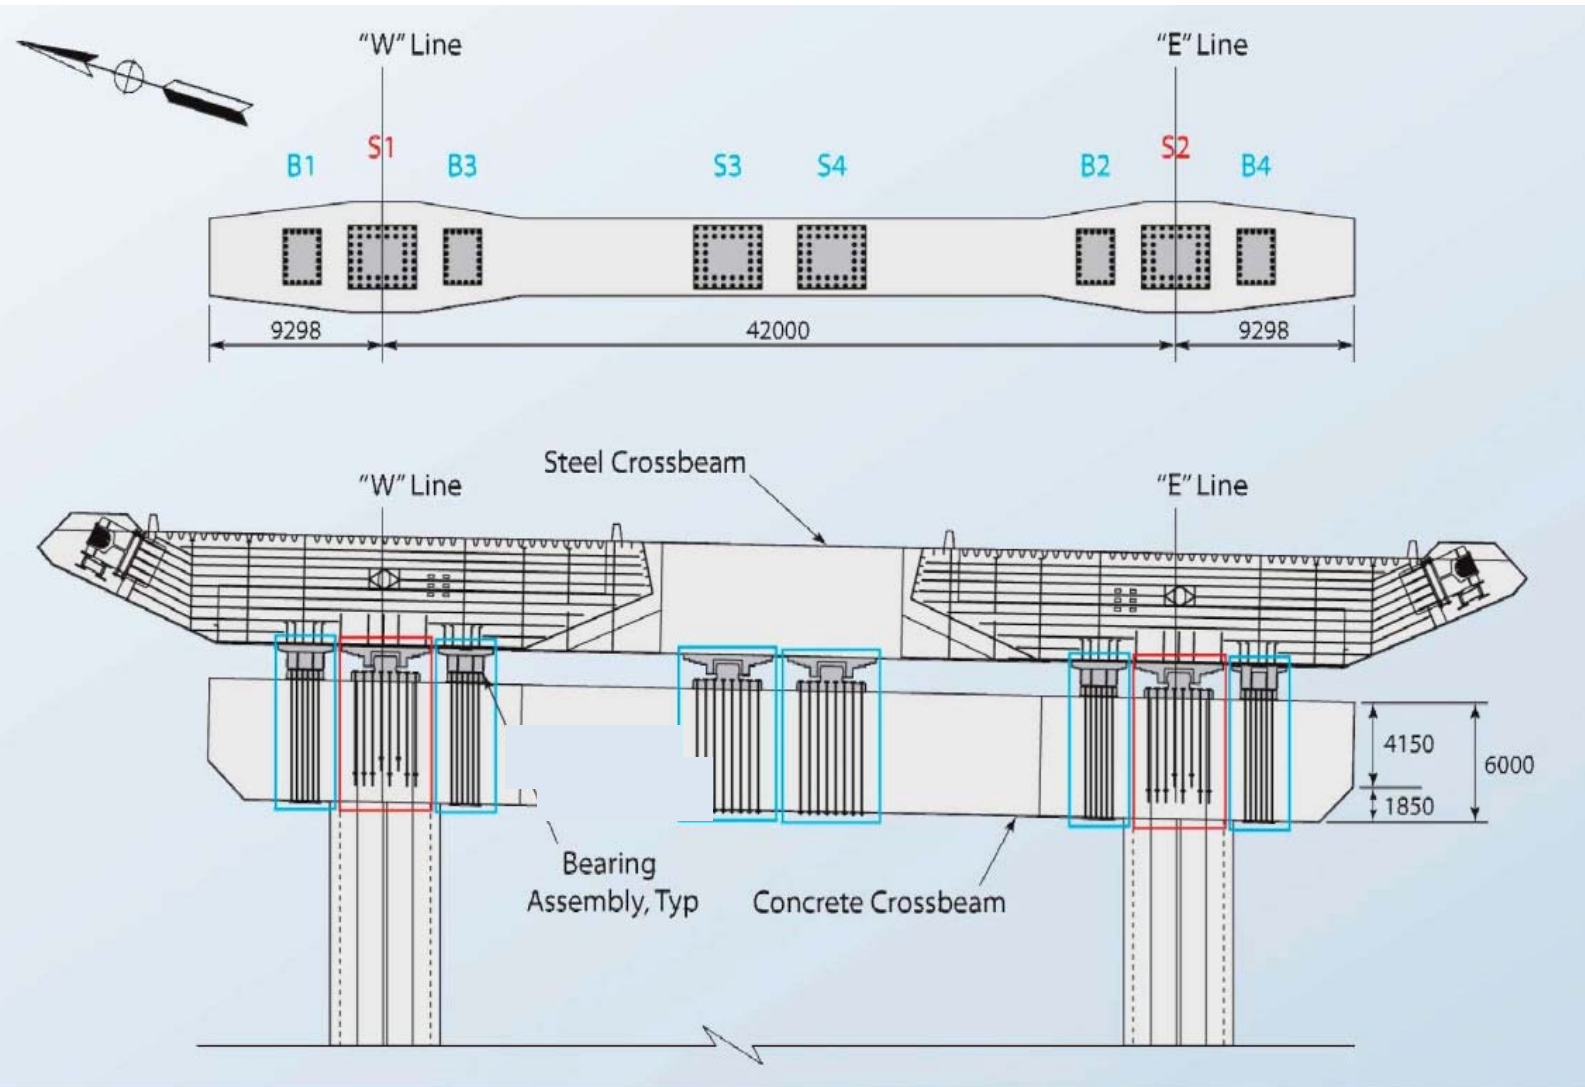
Bearings and Shear Keys on Pier E2

- Rods exhibited a material susceptibility to hydrogen embrittlement with a heterogenous structure and high surface hardness.

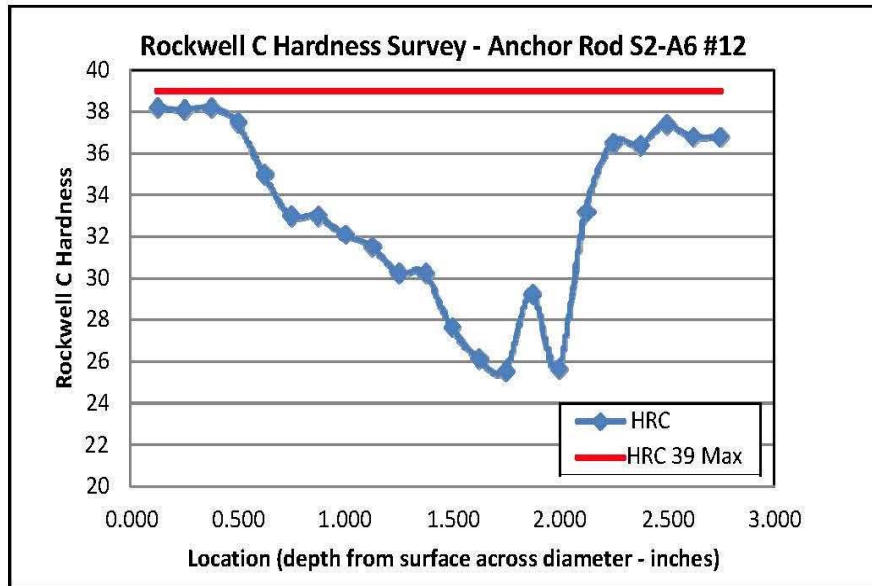
Failed 2008 Rod

Improved Hardness
